Manhole Inspection Summary

Manhole # S15QQ_018MH

Insp Date: **7/28/09 2:21 PM**

Location Address: **TIOGA PKWY**

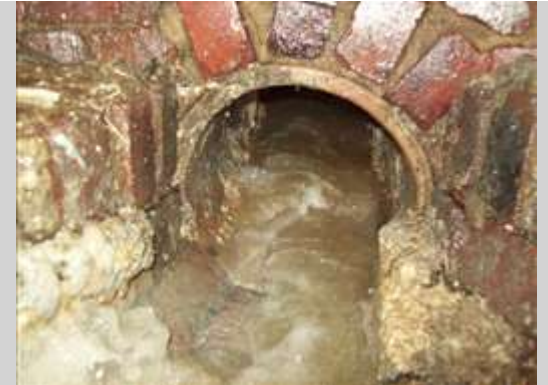
12 O'Clock Outflow

10 in. Circular Gravity Sewer
Pipe Out @ 12 O'Clock

Pipe Height: (in.) Direct
Pipe Material: **Clay** ☐ Pipe Lined
Invert Depth: **26.52** (ft.) Flow Characteristics: **Fast**
Deposits: ☐ None ☐ Mud ☒ Sludge ☒ Debris ☐ Grease
Silt Depth: **3** (in.) Deposits Extent: **Medium**
Infiltration: **None** Pipe Seal Cond: **Sound**

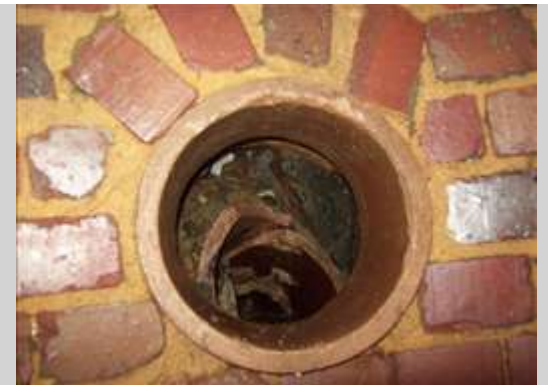
3 O'Clock Inflow

8 in. Circular Gravity Sewer
Pipe In @ 3 O'Clock

Pipe Height: (in.) Direct
Pipe Material: **Clay** ☐ Pipe Lined
Invert Depth: **19.35** (ft.) Flow Characteristics: **Slow**
Deposits: ☐ None ☐ Mud ☒ Sludge ☒ Debris ☐ Grease
Silt Depth: **7** (in.) Deposits Extent: **Heavy**
Infiltration: **None** Pipe Seal Cond: **Unknown**

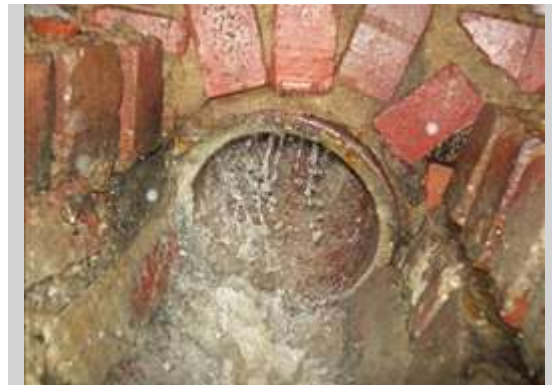
Drop In @ 3 O'Clock

Drop: **Outside Direct**

Inv Depth: **26.05** (ft.)

Drop Condition: **Open**

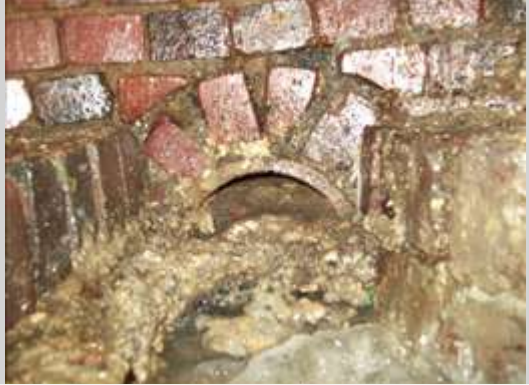
9 O'Clock Inflow

8 in. Circular Gravity Sewer

Pipe In @ 9 O'Clock

Invert Depth: **25.64** (ft.) Flow Characteristics: **None**

Deposits: ☒ None ☐ Mud ☐ Sludge ☐ Debris ☐ Grease

Connects To: **Stub connection / abandoned**
